# Manhole Inspection Summary

Manhole # S35AA\_003MH

Insp Date: **11/13/07 8:49 AM**

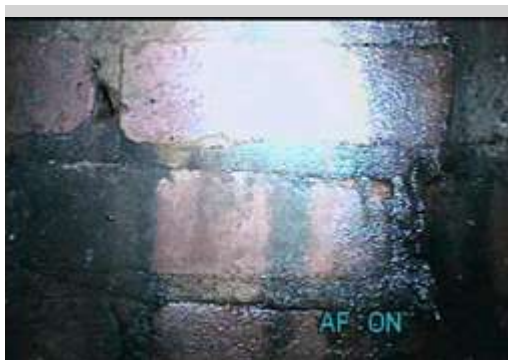
Defect 5

Infiltration: ☐ None ☐ Joint ☐ Cracks ☐ Mortar ☐ Roots ☒ **Wall**

infiltration barrel

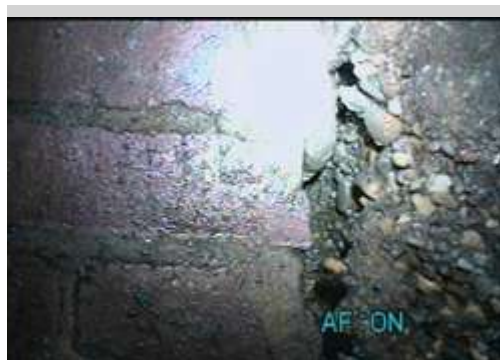
Defect 4

Condition: ☐ Sound ☒ **Cracked** ☐ Root Intrusion ☐ Loose Brick ☒ **Deteriorated**

fracture in barrel above hole

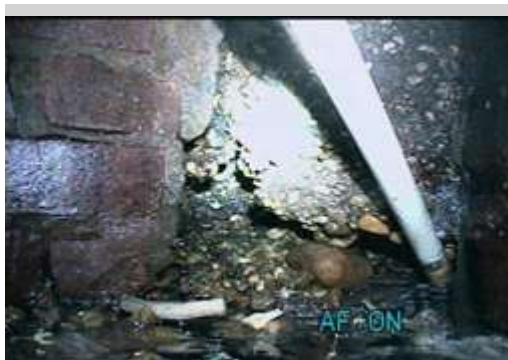
Defect 3

Condition: ☐ Sound ☐ Cracked ☐ Root Intrusion ☐ Deteriorated ☒ **Leaks** ☐ Debris

hole in barrel above bench, leaking

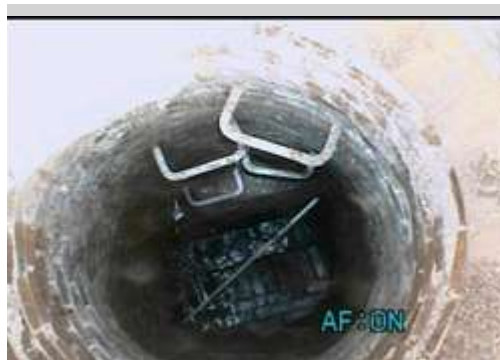
Defect 2

Count: **4** Missing: **0** ☒ **Corroded**

steps

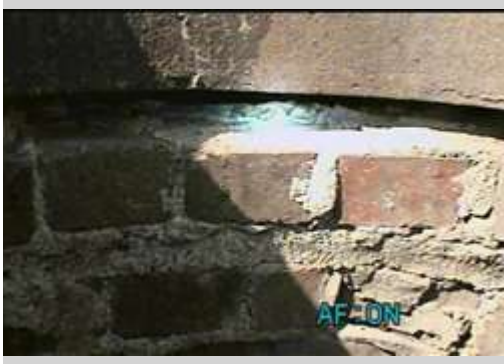
### Defect 1

Condition: ☐ Sound ☐ Cracked ☐ Root Intrusion ☐ Loose Brick ☒ **Deteriorated**

frame adj deteriorated

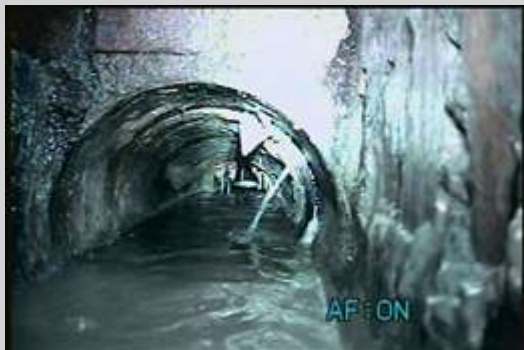
12 O'Clock Outflow

infiltration in pipe

Infiltration: **Runner** Pipe Seal Cond: **Broken**

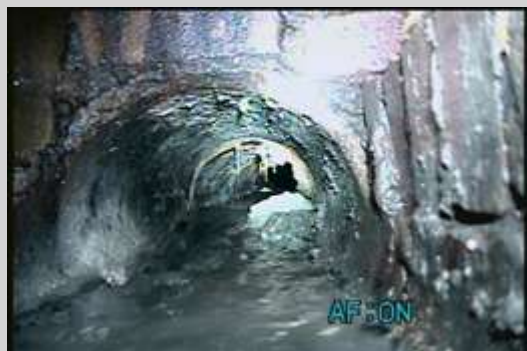
6 O'Clock Inflow

Deposits: ☐ None ☐ Mud ☐ Sludge ☒ **Debris** ☐ Grease

Silt Depth: **3** (in.) Deposits Extent: **Light**
